TECHNICAL REPORT CERC-88-4

EFFECTIVENESS OF EXPEDIENT LEVEE-RAISING STRUCTURES

Experimental Model Investigation

Coastal Engineering Research Center

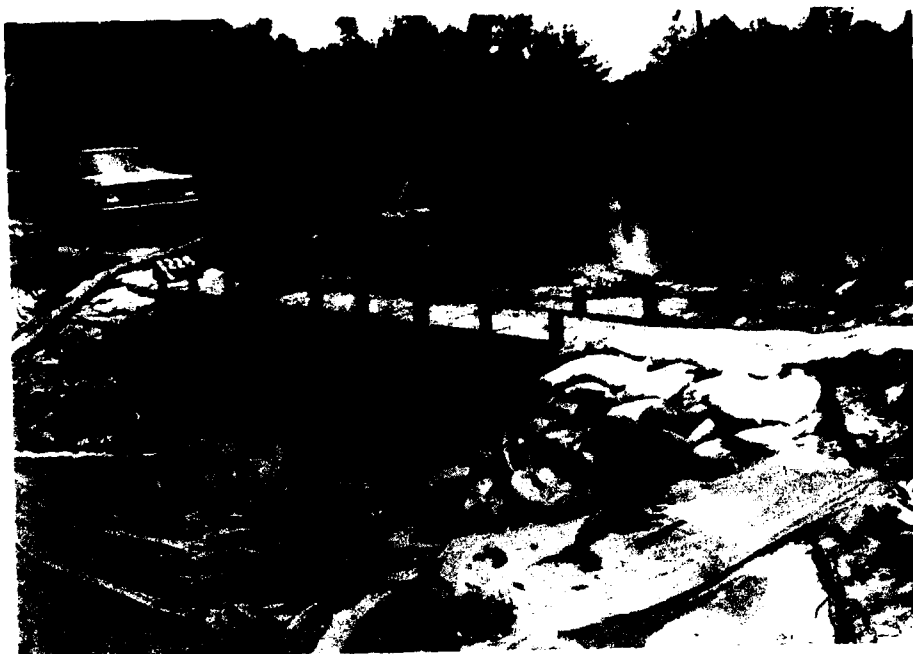
66. Section 4-6. Section 4-6 (Plate 28 and Photos 214 and 215) was a 4-ft-high planking mud box with tamped earth fill. The test section was constructed following the guidelines described in the preceding paragraph. Photos 216-218 show Section 4-6 during various construction phases. The structure was exposed to static differential heads of 1.0, 2.0, 3.0, and 3.5 ft for periods of 24, 72, 24, and 24 hr, respectively. The structure showed no instability or seepage for any of the test conditions. Photos 219 and 220 show the test section at the end of the 3.5-ft static differential head. Following the static differential head tests, the small basin water level was lowered to a 1.0-ft depth, and the structure was exposed to 19 hr of wave action over a period of 168 hr. The test section then was exposed to 4.5 hr of wave action at the 2.0-ft water level over a period of 48 hr. During these two wave and swl conditions, the structure sustained no damage. Wave action at the 3.0-ft water level produced moderate to significant overtopping which kept water ponded on the earth fill (Photos 221 and 222). After 9 hr of wave action at the 3.0-ft level over a period of 96 hr, the earth fill had been lost in one area. With the water ponded on top of the fill, piping of water down through the earth fill and out the landside toe of the structure had caused this material loss. The structure could have been repaired quite easily, but this condition showed that the structure is susceptible to damage once a wave and swl combination is reached that causes wave overtopping (Photos 223-225).

Photo 223. Riverside view of Section 4-6 at the end of the wave action tests

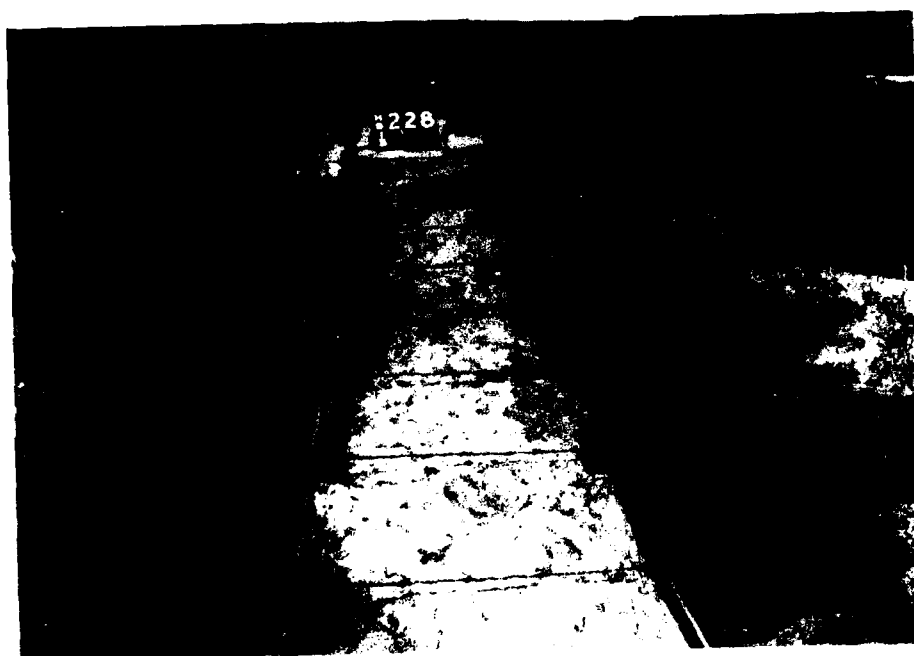
Photo 224. Side view of Section 4-6 at the end of the wave action tests

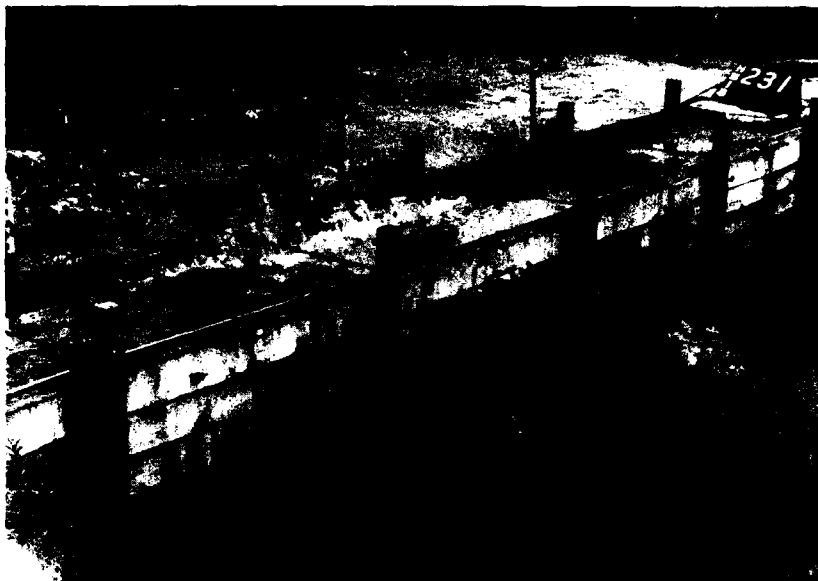
Photo 229. Landside view of Section 4-6-A during wave action at the 3.0-ft water level

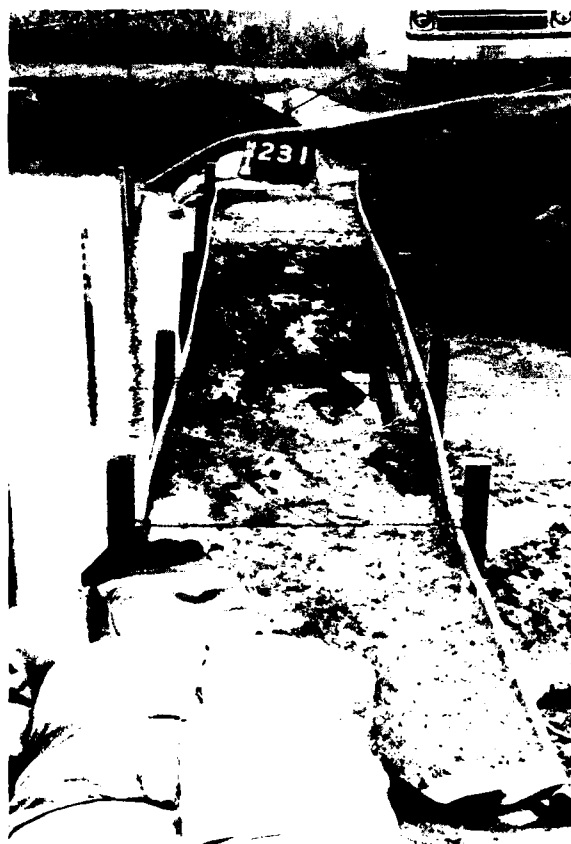
had on Section 4-6 when exposed to overtopping wave conditions. Water ponded on top of the earth fill and began to pipe down through the earth and out the landside toe. As earth fill began to leach out of the structure toe, it was noted that riverside planking began to flex with incident wave attack, and landside planking began to bulge out where the support posts had been removed. This occurrence resulted in a free flow of water and suspended earth fill through gaps between the flexing boards (Photo 229). Thus, it could be seen that increasing spacing between support posts from 3.0 to 6.0 ft had an adverse effect on the structure's stability when exposed to moderate overtopping wave conditions. Photo 230 shows the condition of Section 4-6-A at the end of the test.

Photo 230. Side view of Section 4-6-A at the end of the wave action tests

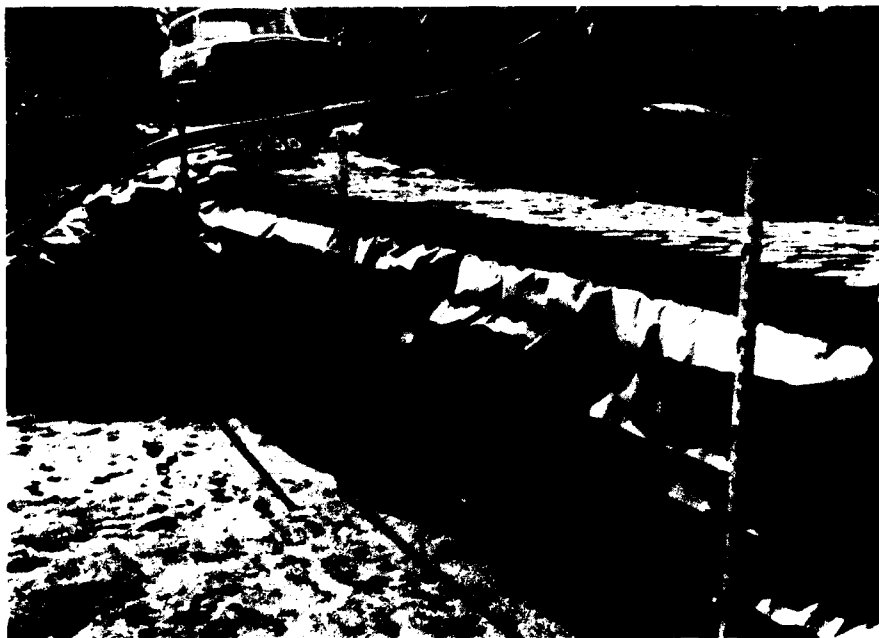
Photo 238. Riverside view of Section 6-1 at the end of the static differential head tests

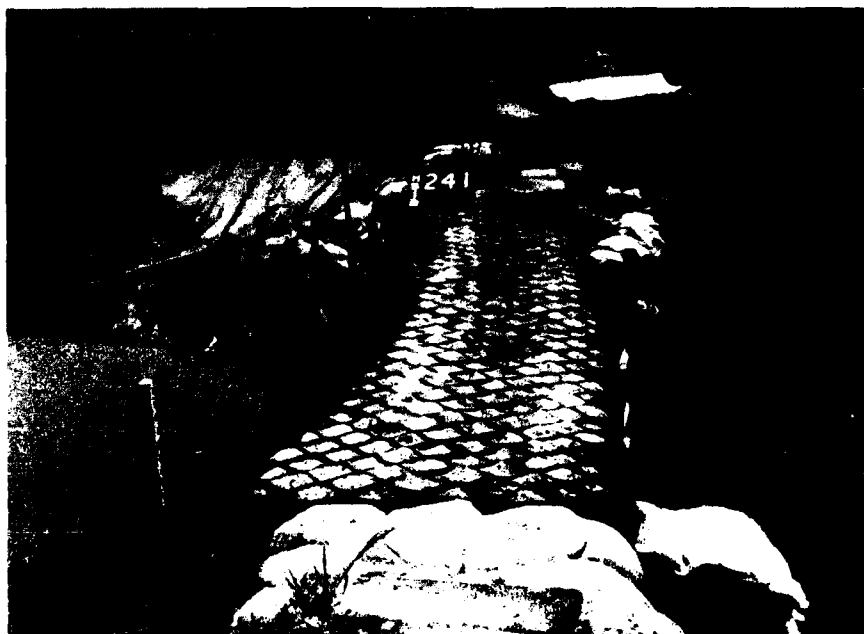
Photo 250. End view of Section 6-1 after 19 hr of wave action at the 4.0-ft water level (Note bow in structure.)

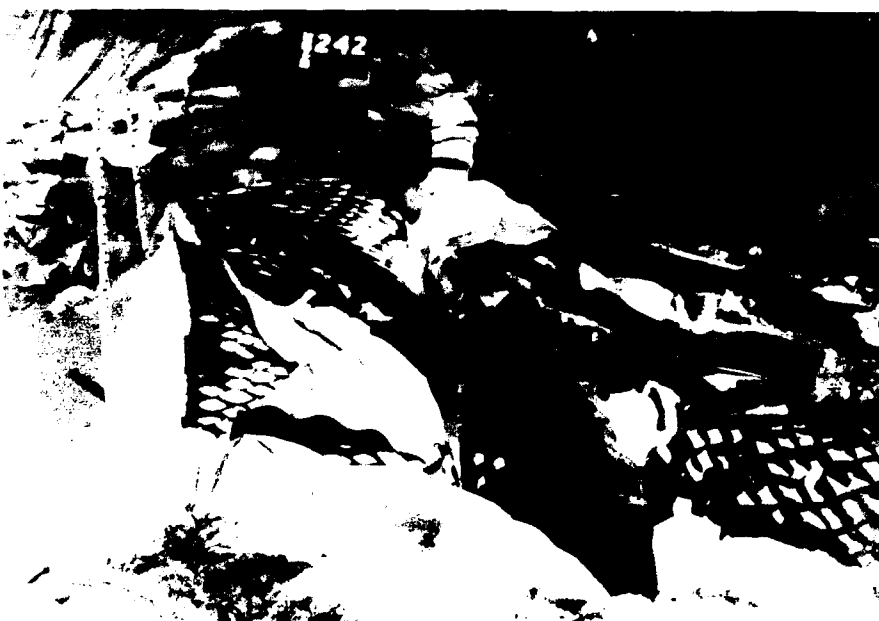
71. During flooding of the basin to carry out wave action at the 5.0-ft water level, the structure failed. When the water had reached 4.9 ft, the structure was displaced landward by a combination of overturning and sliding (Photo 252). Sliding occurred along the top surface of the second lift of cells. Photos 253 and 254 show Section 6-1 after failure.

Photo 254. End view of Section 6-1 at end of test

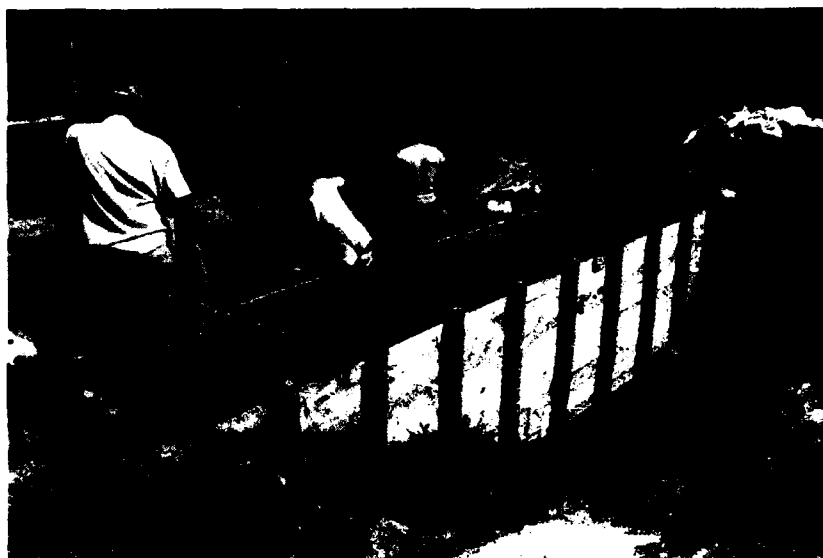
Photo 261. Distributing and tamping earth fill
(clayey silt) on Section 6-2

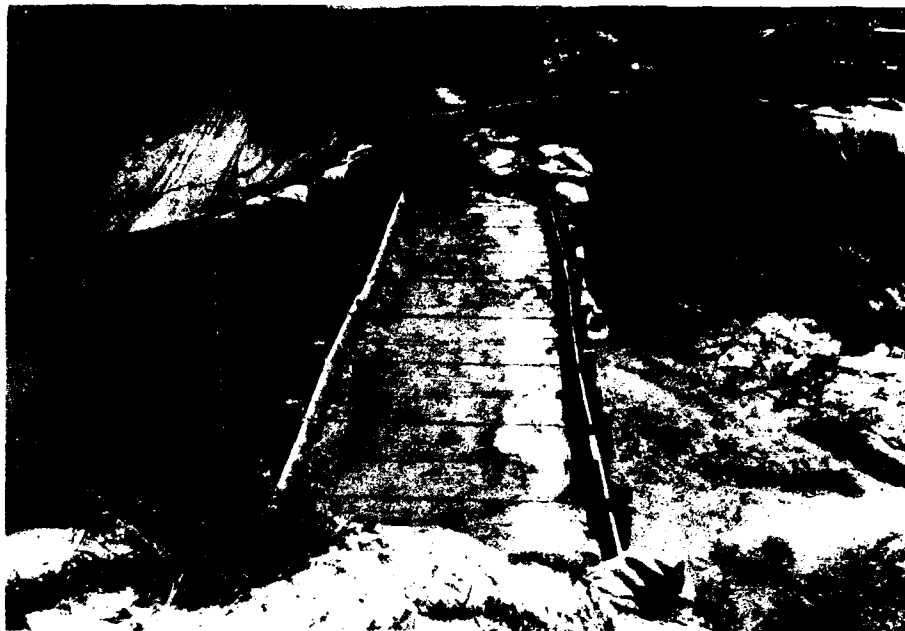
Photo 263. End view of Section 6-2 at the end of the static differential head tests

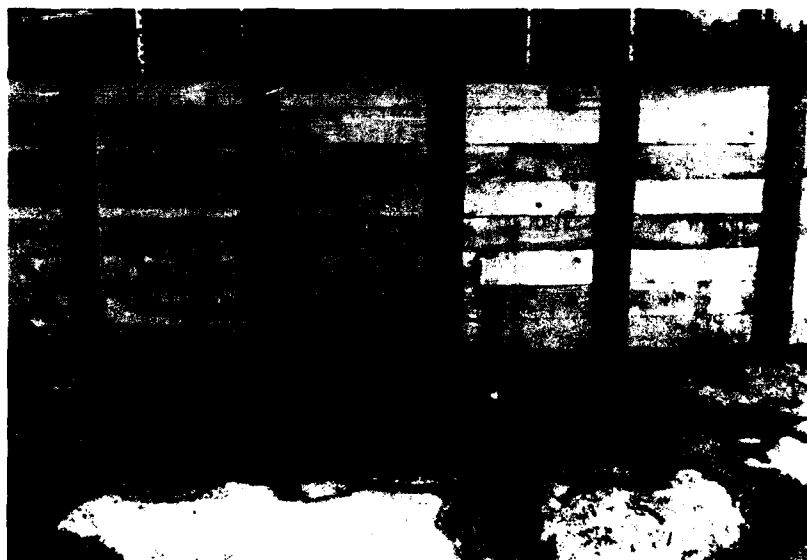
Photo 266. Landside view of water flowing around
center support posts during wave action at the
4.0-ft water level

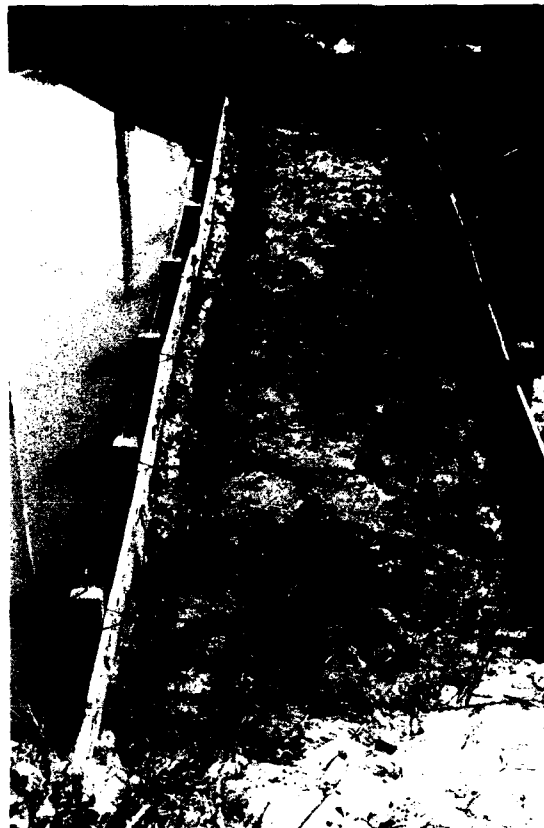
Photo 267. End view of erosion sustained by earth fill during 8.5 hr of wave action at the 4.0-ft water level (end of test)

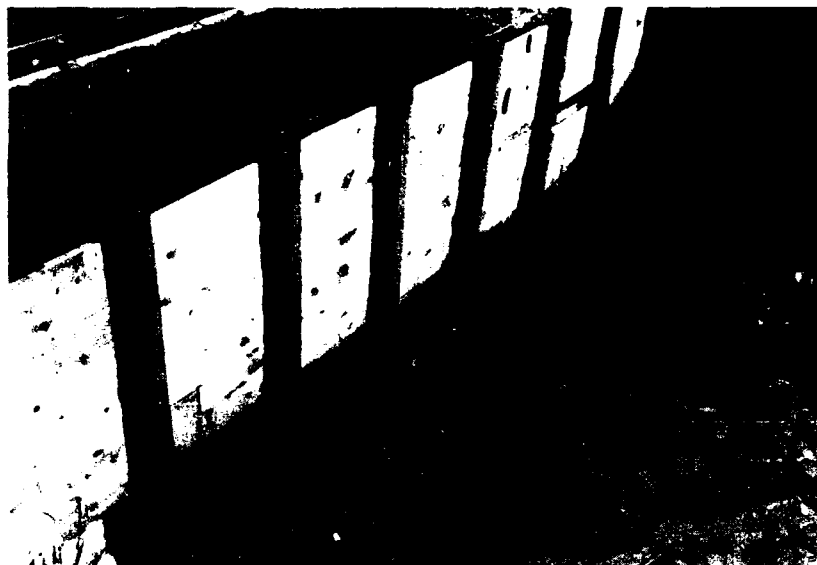
when the tests were stopped, while Photos 268 and 269 show that the planking and support posts were still in good condition.

Photo 269. Landside view of Section 6-2 after 8.5 hr of wave action at the 4.0-ft waver level (end of test)

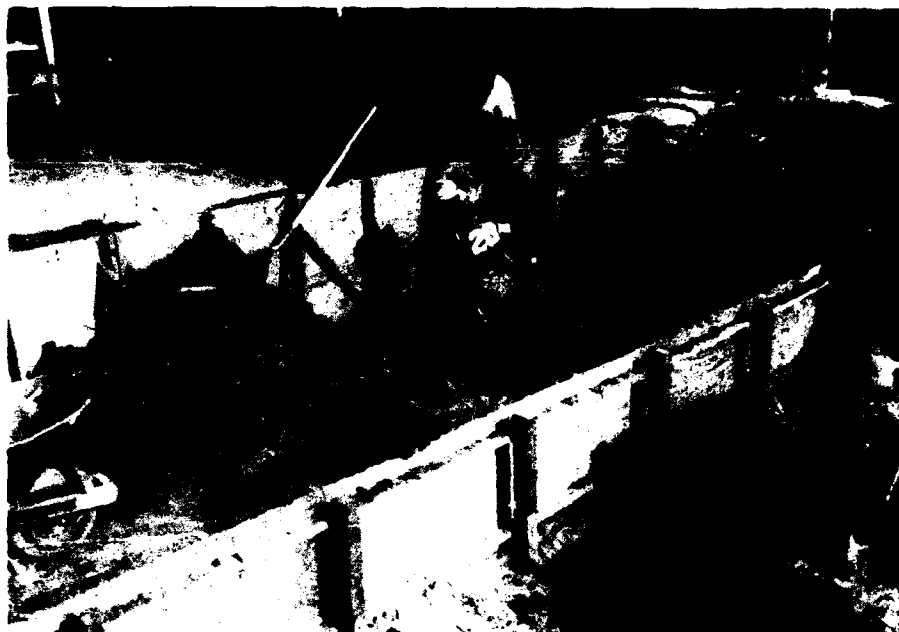
Photo 277. Landside view during the preparation of
Section 6-3-A

78. Section 6-3-A. After discussions with CELMK, it was decided that the 6-ft-high panel needed to be entrenched deeper into the existing levee to determine if this would prevent water from undermining the structure. It was decided that the area of failure on Section 6-3 would be repaired and a 4-in. berm would be constructed on the riverside of the structure which would simulate a total 6-in. entrenching of the 6-ft panel. The failed fill area was cut out (Photo 277), and the area of undermining was filled and compacted well to try to achieve an existing levee compaction density. The fill then was replaced and tamped in the same manner as the original construction. A 4-in.-high, 18-in.-wide berm of material was constructed on the riverside of the 6-ft-high panel. This berm was well compacted and constructed of existing levee soil. The repaired section was referred to as Section 6-3-A (Plate 32 and Photos 278 and 279). Heavy rains occurring after repair was completed and before testing of Section 6-3-A was initiated accounted for the wet appearance in before-test photographs.

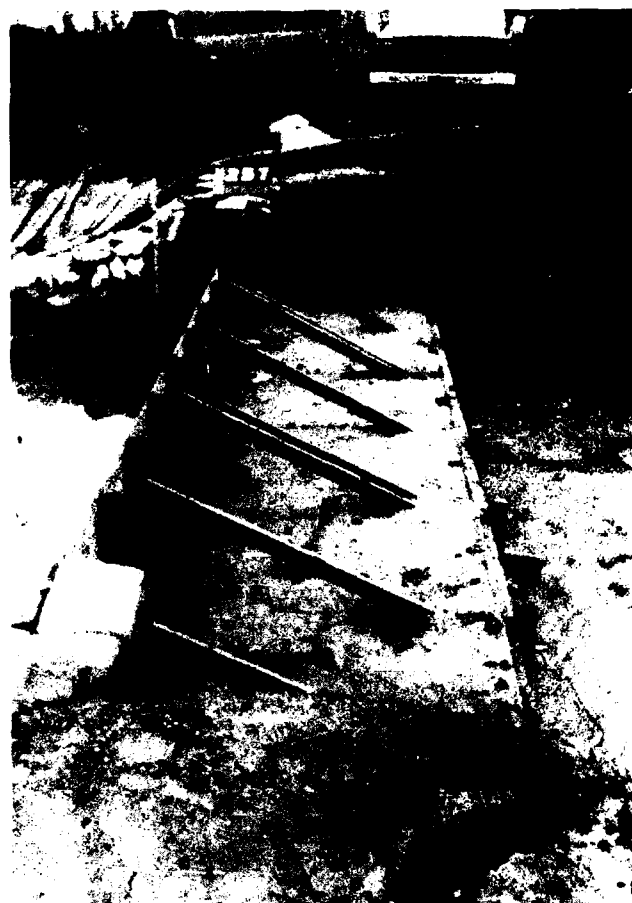
Photo 279. End view of Section 6-3-A before testing

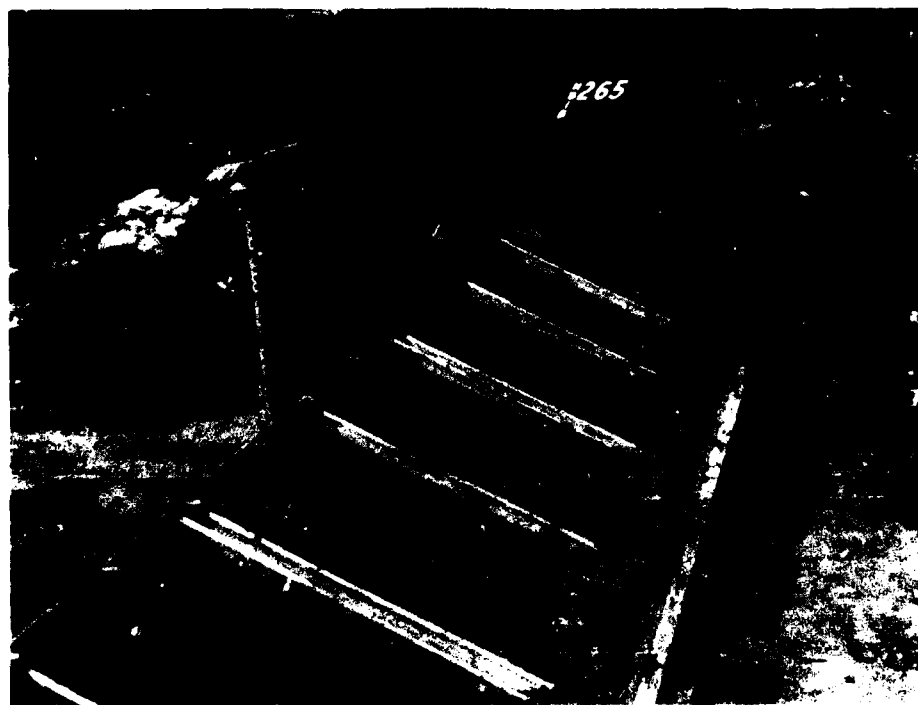
80. Section 6-4. After discussions of the test results of Section 6-3-A with CELMK, it was decided to make design modifications in the 6.0-ft-high plywood mud box that would allow for its 6-in. entrenchment into the existing levee. This new design was referred to as Section 6-4 (Plate 33 and Photos 281 and 282). The vertical 2-in. by 4-in. braces on the riverside panels (item "K", Plate 33) were shortened to 5 ft 6 in. so they would not extend into the trench. A 6-in.-deep trench was excavated, and the riverside panel (Panel B) was placed as far riverward in the trench as possible (Photo 283). The clayey silt fill material was thoroughly compacted in the trench with hand tampers, while the remainder of the clayey silt earth fill was dumped from a small bucket loader (Photo 284), distributed with shovels, and tamped into place by personnel walking over the fill that was placed in 6- to 8-in. lifts.

Photo 282. End view of Section 6-4 before testing

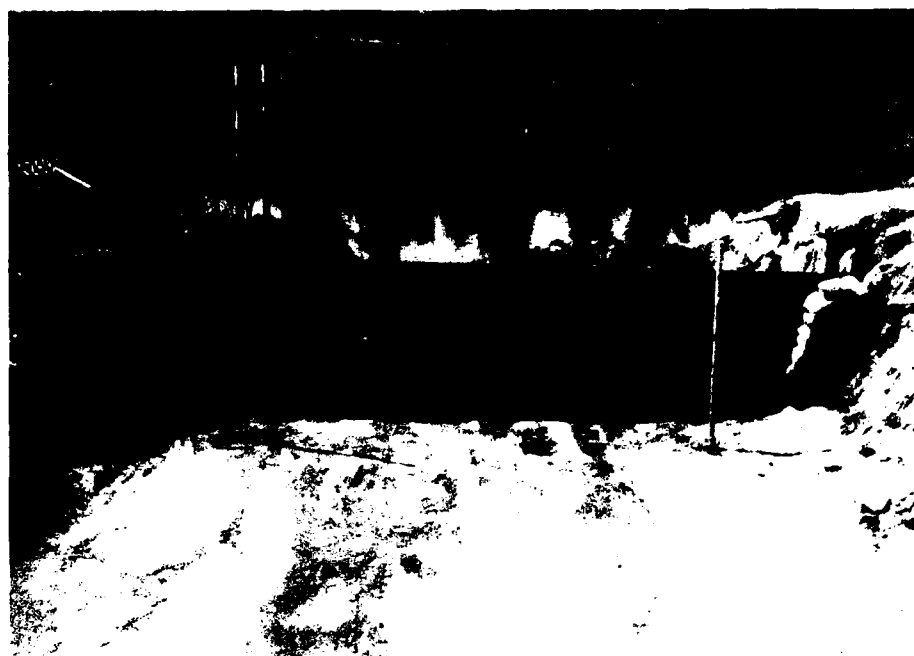
84. The mud boxes were modified as described above, set in place with the riverside plywood positioned in the middle of the 6-in.-deep trench and nailed together (Photo 289). The riverside of the trench was backfilled with clayey silt and thoroughly compacted by hand, while the landside of the trench (landside of Panel B) was filled and compacted by foot tamping. As was done on Section 6-4, the remaining earth fill (clayey silt) was placed with a small bucket loader, distributed by shovel in 6- to 8-in. lifts, and lightly tamped by walking (Photo 290). Photos 291 and 292 show Section 6-5 after construction was completed and before tests were started.

Photo 291. Riverside view of Section 6-5 before testing

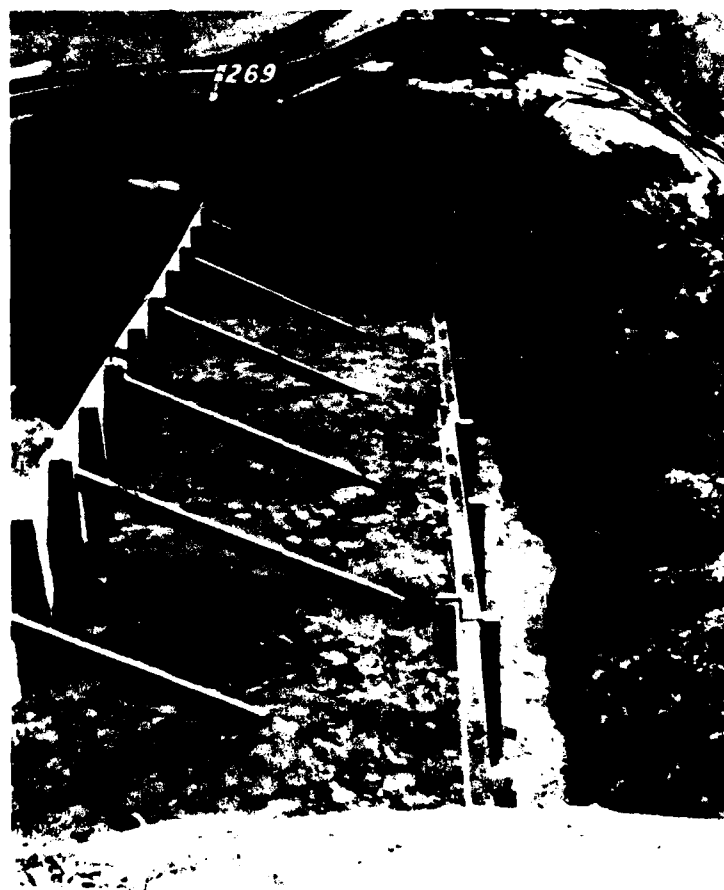
Photo 292. End view of Section 6-5 before testing

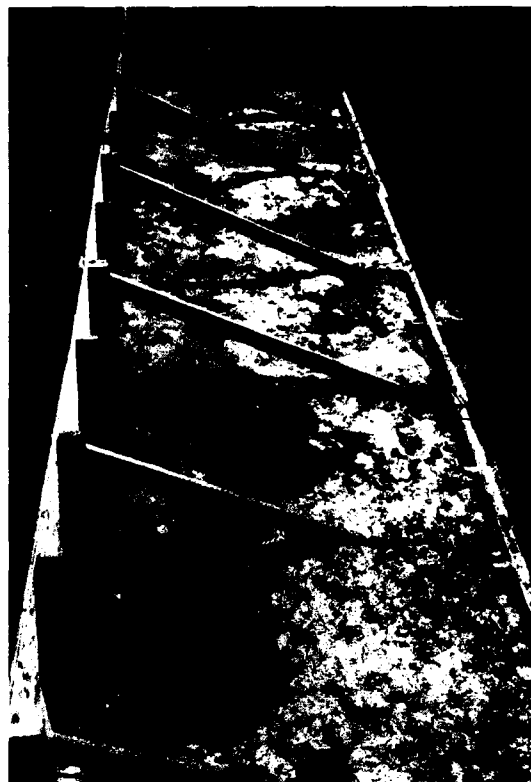
85. Section 6-5 was exposed to 1.0-, 2.0- and 3.0-ft static differential heads for 24 hr each. The 1.0-ft head produced no seepage, while a small amount of seepage was noticeable after 2 hr of 2.0-ft head. This seepage stopped, however, after 4 hr. A minor amount of sustained clear water seepage was observed throughout the 3.0-ft head test. After 24 hr at the 3.0-ft head, about one half of the fill was wet, and a small amount of water had ponded around two of the vertical supports on Panel B (Photo 293). No increase in seepage rate was noted after 24 hr, and no obvious erosion of the earth fill was occurring. The static head was raised to 4.0 ft. After 2 hr, the entire earth fill was wet, and water had pooled in several areas on the earth fill (Photo 294). The water appeared to be coming up the riverside of the earth fill adjacent to the vertical supports, and plywood and was moving across the fill and piping down the landside of the fill adjacent to the plywood and vertical supports of Panel A.

Photo 294. End view of Section 6-5
after 2.0 hr of the 4.0-ft static
differential head test

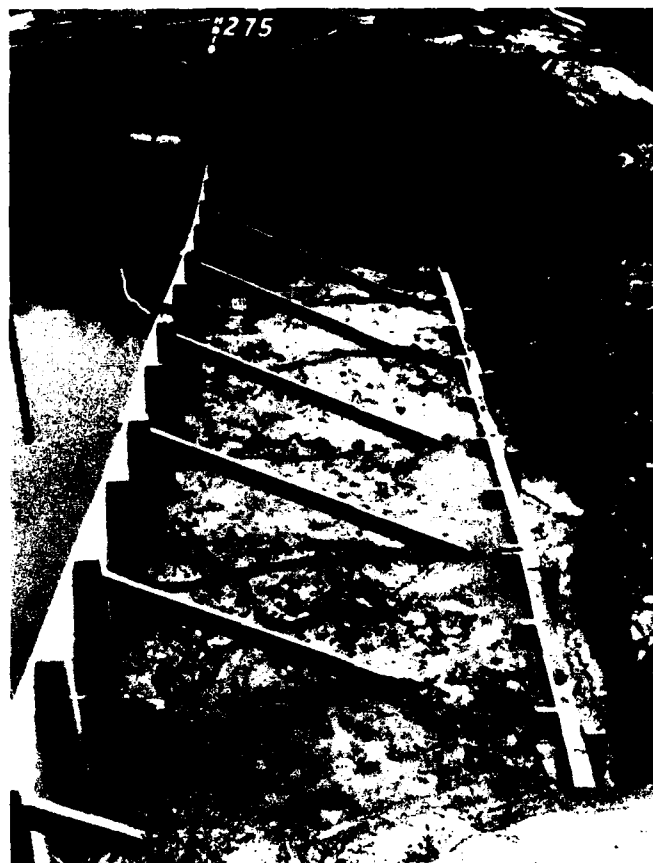
86. After 24 hr, the seepage rate had not increased, but the static condition was maintained for an additional 72 hr to see if the structure would fail or sustain any appreciable damage. After 96 hr of 4.0-ft head, water had ponded in several areas of the saturated earth fill, which showed some consolidation and minor surface erosion (Photo 295). The seepage rate had not increased over the 96 hr, and the water remained clear. When the static head was increased to 5.0 ft, the seepage rate increased but was still only

Photo 295. End view of Section 6-5 at the end of the 4.0-ft static differential head test

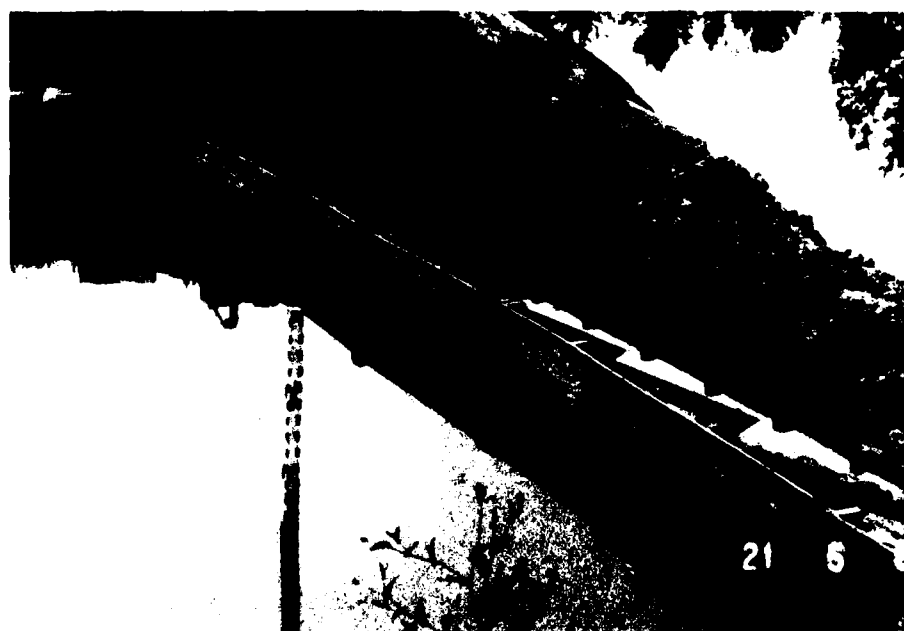
Photo 296. Riverside view of Section 6-5 at the end of the 5.0-ft static differential head test

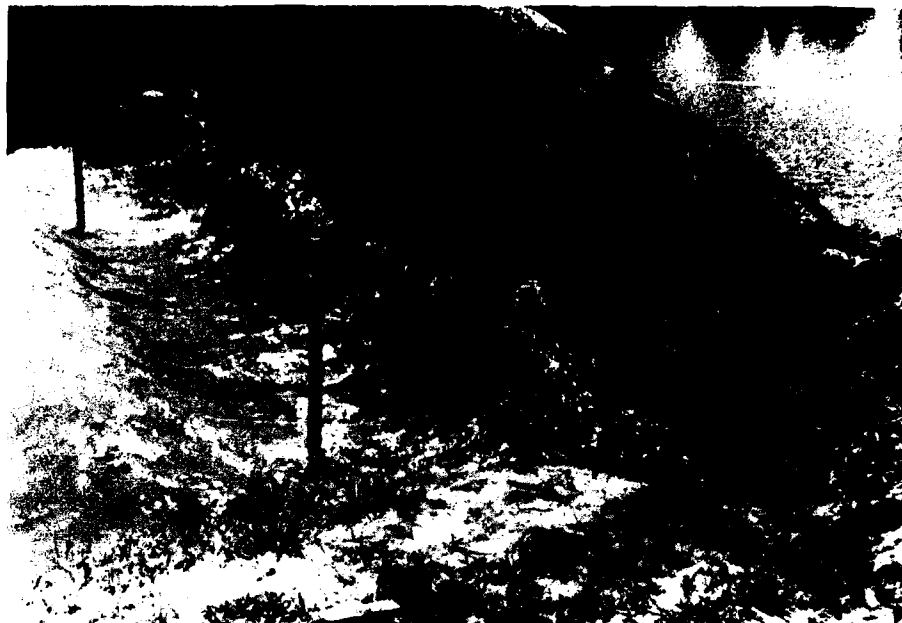
Photo 299. Riverside view of Section 6-5 during wave attack at the 4.0-ft water level

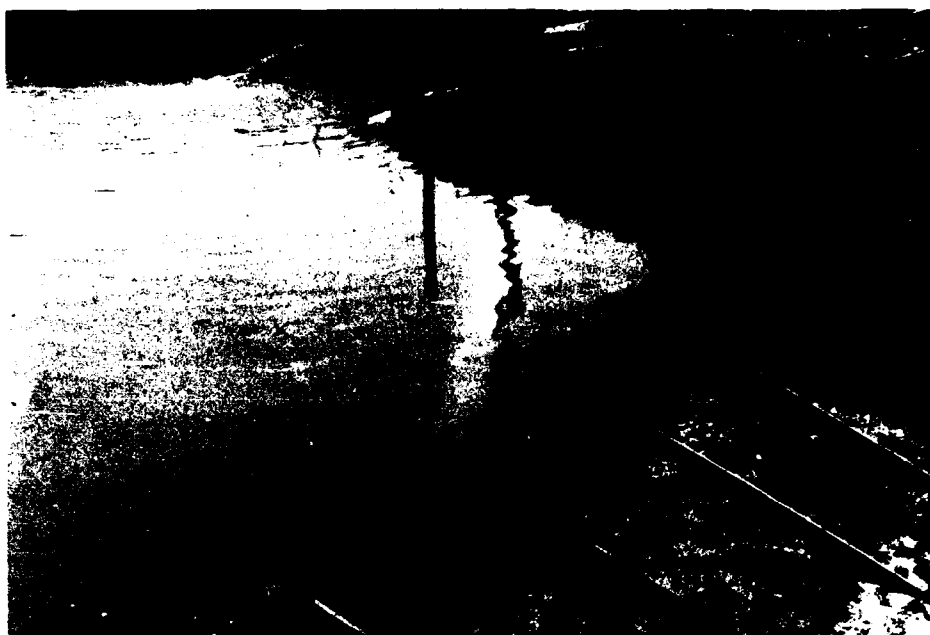
Photo 301. End view showing Section 6-5 holding a 5.5-ft static differential head

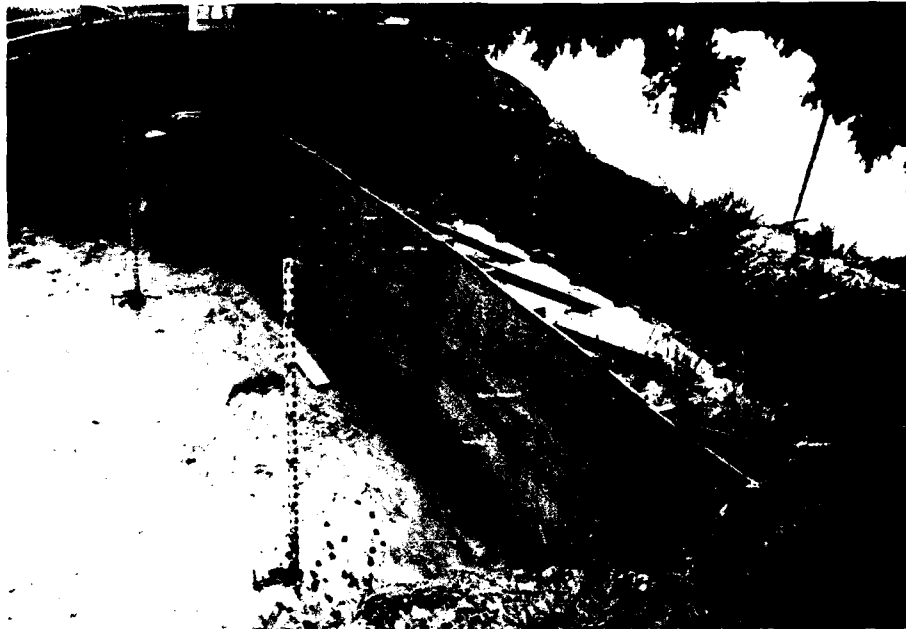
87. Water ponding on the earth fill had eroded around the end of Panel A where it was in contact with the bank of the cut area in the existing levee. This ponding caused some minor erosion of the earth fill but did not show any signs of causing a failure of the earth fill (Photo 298). This damage was not felt to be representative, except for a prototype condition where the mud box was being used to close a cut area. In that case, sandbags or some other type of reinforcement could be used in this area. The mud boxes were exposed to 5.5 hr of wave action at the 4-ft water level over a period of 168 hr. This combined wave and swl caused only minor, sporadic wave overtopping (Photos 299 and 300). The waves impacting on Panel B caused some very slight flexing of the plywood, but this did not seem to increase in severity or result in additional problems. The wave overtopping did result in an increase in rate of water loss from the small wave basin and increased ponded water on the earth fill. The seepage rate through the structure showed no noticeable increase when wave action was stopped, and the earth fill showed only superficial surface erosion. The water level was increased to 4.7 ft, and wave action was continued to see what effects increased loading would have on the structure and increased overtopping would have on the earth fill. This condition caused significant, sporadic wave overtopping, but because of the amount of clay in the fill, the erosion rate was quite slow. Panel B showed a slightly higher degree of flexing, but it showed no signs of failure. This condition was maintained for 1.5 hr, and the only damage noted was a small trench cut in the earth fill where overtopping water was impacting. (In Photo 301 note ponded water in trench cut by overtopping water.) The water level was increased to 5.5 ft (top of Panel B) and left overnight. This was done to see if the structure, in its somewhat deteriorated condition, could withstand this maximum static load. The seepage rate showed a slight increase (1.5 ft of water lost overnight), but the structure stood the test condition quite well. Photos 302-304 show the condition of the structure after the basin was drained.

Photo 303. End view of Section 6-5 at end of test
